**Flood Control Project Maintenance
Levee Inspections**
LMA District Cover Sheet
Spring 2017 Levee Inspection Results

Reclamation District No. 0341 Sherman Island

Spring 2017 Levee Inspection Results

| Waterway | | | Bank | Unit Miles |
|--|---|---|---|---|
| Unit No. 01 Threemile Slough | | | Right | 3.36 |

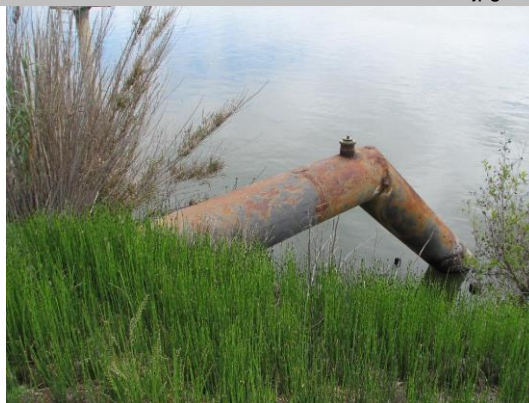
Photo 2 of 3 : UCIP_SP_2017_22063_37644.jpg

FS_ID:22063
DS_ID:24215
EP_NO: N/A
Repair Type: Non-Urgent
Crossing Status: Found
UCIP Comments: Dense vegetation limits the inspector's visibility to identify signs of pipe failure (leaks) along the slopes. Recommend removing vegetation along pipe alignment to conduct proper inspection of structure and appurtenances.
FIELD_STRUCT_DESC: 30-inch steel drainage pipe through the levee, 11.1 feet below the crown. CM cutoff wall around pipe at center of levee. Siphon breaker on both sides. Pump on landward side approximately 300 feet from landward toe. Pipe exposed on both levee slopes. Rock revetment on waterward slope. (USACE-1962). This entry matches the Drainage or Irrigation Structure referenced in O&M manual (HLM 0.0). Marine Station number 1 located on waterward side with attached small solar panel on top.
FS Date: 5/5/2009

View of pipe and siphon breaker located on waterward side--dense vegetation on slope.

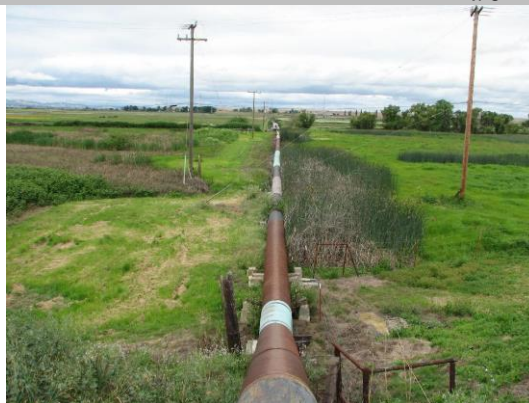
Photo 3 of 3 : UCIP_SP_2017_22063_37642.jpg

Overview of landward slope above ground once it exits levee. Pump is located approximately 300 feet from levee toe.

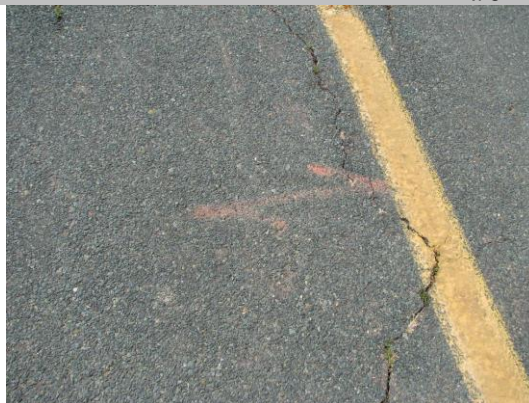
Photo 1 of 3 : UCIP_SP_2017_22064_37647.jpg

| FS_ID:22064 DS_ID:24110 EP_NO: 6297 Repair Type: Non-Urgent Crossing Status: Found UCIP Comments: Markers Missing. No markers found to confirm crossing is still in use--need to contact owner to determine status of crossing. FIELD_STRUCT_DESC: 3-inch electrical conduit through the levee, 3.5 feet below the crown. Location marker on waterward shoulder--no marker found. Pole on landward side. Rock revetment on waterward slope. (Permit No. 6297-1969) FS Date: 5/5/2009 | | | | | |

Underground Service Alert (USA) markings on road surface indicating line is still present.

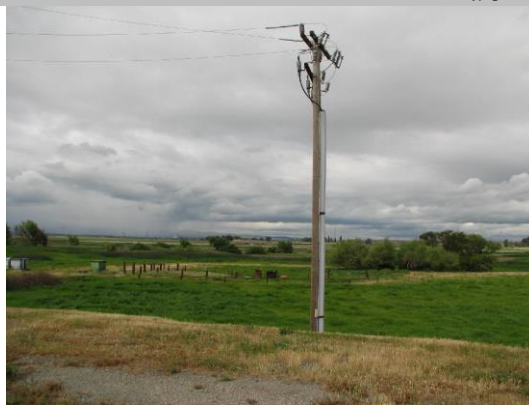
Photo 3 of 3 : UCIP_SP_2017_22064_37645.jpg

| UCIP Comments: Markers Missing. No markers found to confirm crossing is still in use--need to contact owner to determine status of crossing. | | | | | | |

Power pole located on landward side aligns with crossing.

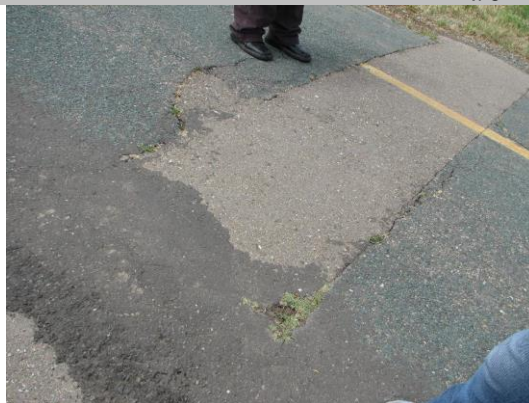
Photo 1 of 3 : UCIP_SP_2017_22068_37654.jpg

FS_ID:22068
DS_ID:24111
EP_NO: 1477
Repair Type: Non-Urgent
Crossing Status: Found
UCIP Comments: Dense vegetation limits the inspector's visibility to identify signs of pipe failure (leaks) along the slopes. Recommend removing vegetation along pipe alignment to conduct proper inspection of structure and appurtenances.
FIELD_STRUCT_DESC: 10-inch steel pipe through the levee, 1.8 feet below the crown. Pipe is encased in 12-inch CM condutor pipe under crown. Pump on landward side. Air vent and metal distribution box with gate on the landward side. Rock revetment on the waterward slope. (USACE-1962). This entry matches the Drainage or Irrigation Structure referenced in O&M manual (HLM 0.50). 30-feet of pipe under crown was replaced and encased in CM pipe under Permit No. 1477 (1950).
FS Date: 5/5/2009

Cut along pipe alignment--unknown repair or maintenance date.

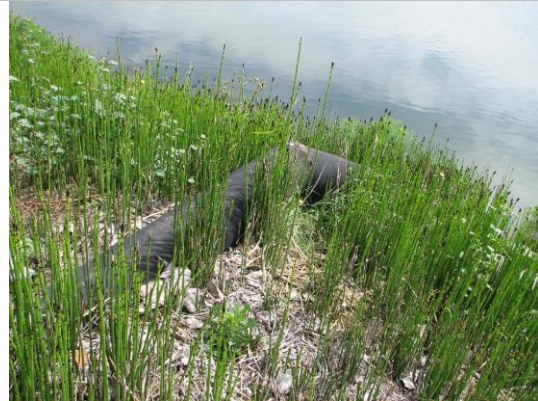
Photo 3 of 3 : UCIP_SP_2017_22068_37655.jpg

| FS_ID:22068 DS_ID:24111 EP_NO: 1477 Repair Type: Non-Urgent Crossing Status: Found UCIP Comments: Dense vegetation limits the inspector's visibility to identify signs of pipe failure (leaks) along the slopes. Recommend removing vegetation along pipe alignment to conduct proper inspection of structure and appurtenances. FIELD_STRUCT_DESC: 10-inch steel pipe through the levee, 1.8 feet below the crown. Pipe is encased in 12-inch CM condutor pipe under crown. Pump on landward side. Air vent and metal distribution box with gate on the landward side. Rock revetment on the waterward slope. (USACE-1962). This entry matches the Drainage or Irrigation Structure referenced in O&M manual (HLM 0.50). 30-feet of pipe under crown was replaced and encased in CM pipe under Permit No. 1477 (1950). FS Date: 5/5/2009 | | | | | | |

View of pipe on waterward side.

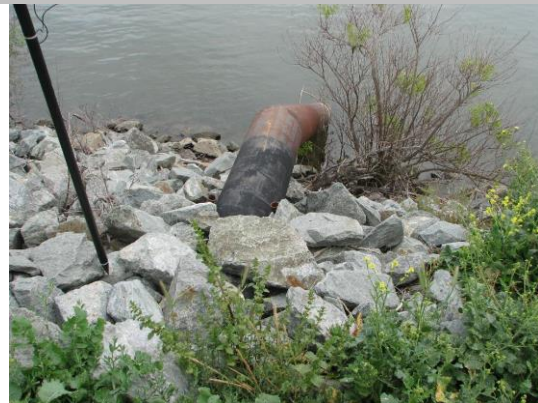
Photo 1 of 3 : UCIP_SP_2017_22070_37664.jpg

| UCIP Comments: Dense vegetation limits the inspector's visibility to identify signs of pipe failure (leaks) along the slope. Recommend removing vegetation along pipe alignment to conduct proper inspection of structure and appurtenances. | | | | | |

View of pipe located on waterward side.

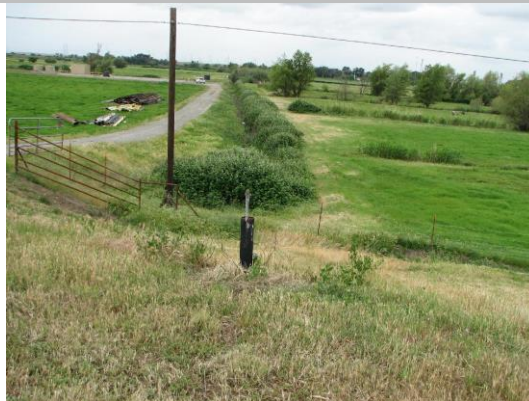
Photo 2 of 3 : UCIP_SP_2017_22070_37663.jpg

View of landward side--visible standup pipe on slope.

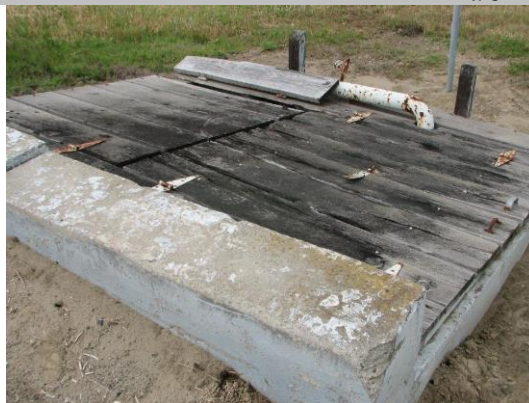
Photo 1 of 3 : UCIP_SP_2017_22074_37675.jpg

| FS_ID:22074 DS_ID:24115 EP_NO: N/A Repair Type: Non-Urgent Crossing Status: Found UCIP Comments: Need to contact owner to determine if crossing is still active and to determine last inspection date. Will need copy of letter showing crossings passed inspection. NEED photo of emergency contact information from marker. FIELD_STRUCT_DESC: 10-inch steel gas line through the levee. Valve in concrete box on the landward side. (USACE-1962). This entry matches the Drainage or Irrigation Structure referenced in O&M manual (HLM 1.42). FS Date: 5/5/2009 | | | | | |

Concrete box located on landward side.

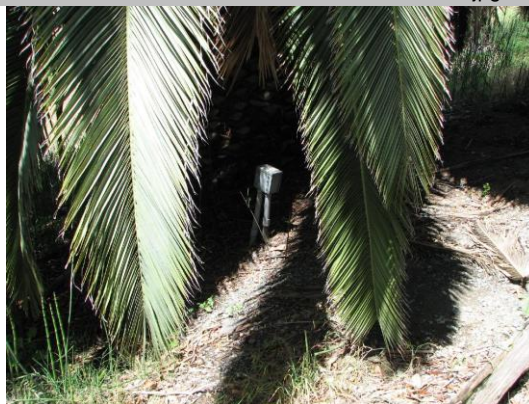
Photo 2 of 3 : UCIP_SP_2017_22086_37704.jpg

| FS_ID:22086 DS_ID:24116 EP_NO: 11103 Repair Type: Non-Urgent Crossing Status: Found UCIP Comments: Unable to determine if crossing is the same as permitted under permit no. 11103. Need to contact owner and determine status of crossing under permit no. 11103. Believe steel conduit is exposed on landward side. FIELD_STRUCT_DESC: 1.5-inch iron water pipe and 3.5-inch electrical steel conduit through the levee, both 3.0 feet below the crown. Pressure system and service pole on landward slope. Fishing resort on waterward side. This pipe was retained under ABO No. 11103 (1975). FS Date: 5/5/2009 | | | | | |

Power connection on waterward side no other appurtenances found.

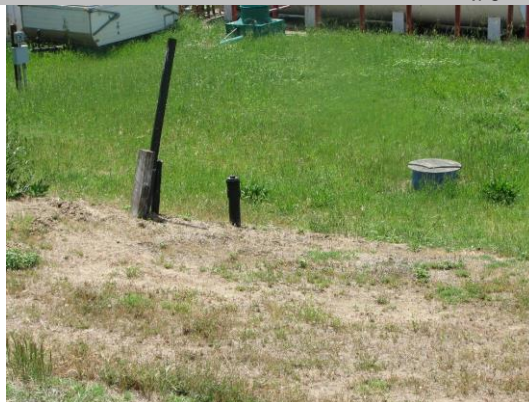
Photo 1 of 3 : UCIP_SP_2017_22091_37712.jpg

| FS_ID:22091 DS_ID:24117 EP_NO: 5427 Repair Type: Non-Urgent Crossing Status: Indicator Found UCIP Comments: Unable to find pipe or sump pump. Indicators found on landward side include potential septic tank and observation well. Need to contact owner of crossing to determine status of crossing. FIELD_STRUCT_DESC: 1 of 2: 4-inch diameter pipe sleeved through 6-inch pipe through the levee, 3.7 feet below the crown. Sump pump on waterward slope. Septic tank and observation well on the landward side. (Permit No. 5427-1966) FS Date: 5/5/2009 | | | | | |

View of potential observation well on landward side.

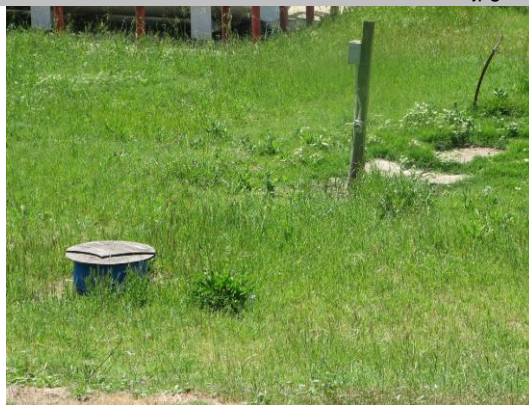
Photo 2 of 2 : UCIP_SP_2017_22093_37716.jpg

Electrical connection visible next to concrete pad--right corner.

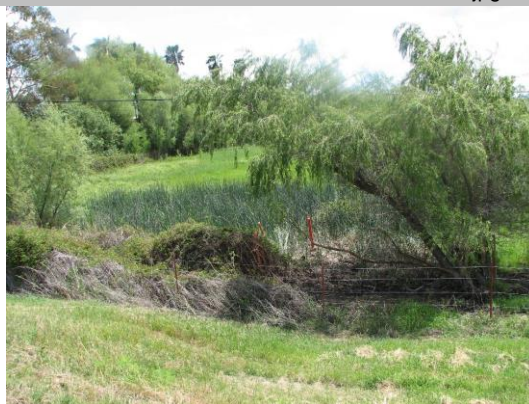
Photo 2 of 2 : UCIP_SP_2017_22098_37723.jpg

| FS_ID:22098 DS_ID:24242 EP_NO: 960 Repair Type: Non-Urgent Crossing Status: Indicator Found UCIP Comments: Need to contact owner to determine last inspection and status of crossing. FIELD_STRUCT_DESC: 2 of 2: 10-inch gas line through the levee, 2.0 feet below the crown. Cutoff wall around pipes at center of levee. Valve pit on landward shoulder, with 2-inch drain pipe along landward slope. Location marker on waterward slope. (Permit No. 960-1944) This entry matches the Drainage or Irrigation Structure referenced in O&M manual (HLM 2.04). Pipe video inspected by PG&E under Permit No. 15319 (1990). FS Date: 5/5/2009 | | | | | |

Markers also visible on landward side near levee toe.

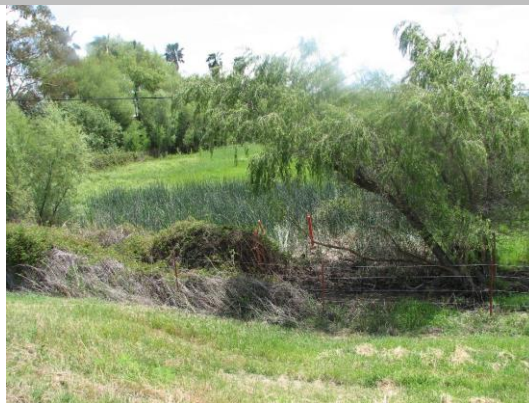
Photo 2 of 2 : UCIP_SP_2017_39860_71846.jpg

FS_ID:39860
DS_ID:24756
EP_NO: 17251
Repair Type: Non-Urgent
Crossing Status: Indicator Found
UCIP Comments: Need to contact owner to determine status of crossing. Need date of last inspection and confirmation that crossing is still in operable condition.
FIELD_STRUCT_DESC: 24-inch steel natural gas pipeline through the levee 125-feet below the crown (Permit No. 17251, 2002).
FS Date: 3/4/2014

Markers visible on landward toe.

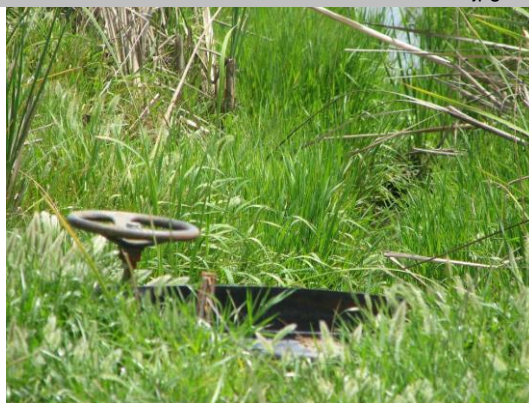
Photo 2 of 3 : UCIP_SP_2017_22106_37733.jpg

| FS_ID:22106 DS_ID:24120 EP_NO: 11102 Repair Type: Non-Urgent Crossing Status: Found UCIP Comments: Dense vegetation limits the inspector's visibility to identify signs of pipe failure (leaks) along the slope. Recommend removing vegetation along pipe alignment to conduct proper inspection of structure and appurtenances. FIELD_STRUCT_DESC: 10-inch pipe sleeved through 12-inch pipe through the levee, 4.6 feet below the crown. Annular gap grouted. Siphon breaker at landward shoulder. Pump on landward side. Irrigation canal with distribution box at landward toe. Rock revetment on waterward slope. This entry matches the Drainage or Irrigation Structure referenced in O&M manual (HLM 2.33). This pipe was retained under ABO No. 11102 (1975). FS Date: 5/5/2009 | | | | | |

Riser and gate visible on waterward side--dense vegetation limits inspection.

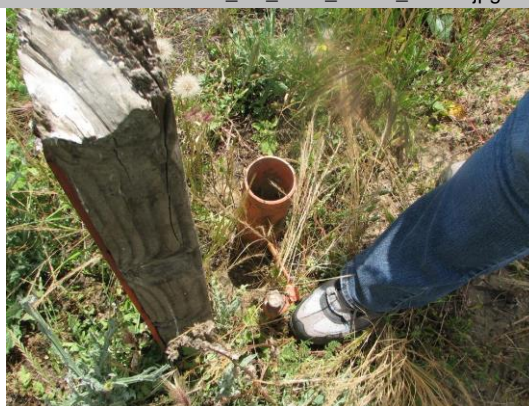
Photo 3 of 3 : UCIP_SP_2017_22112_37747.jpg

Small stand pipe located on waterward side--unknown purpose of stand pipe.

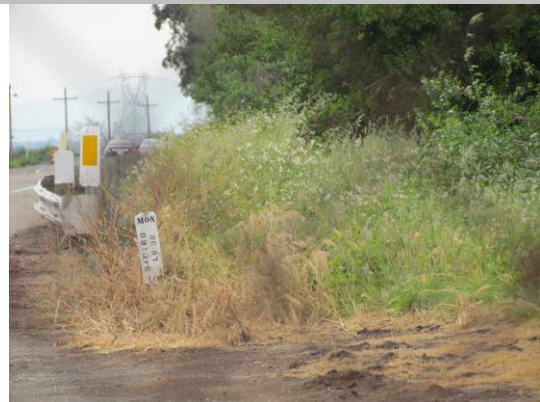
Photo 1 of 1 : SP_2017_RD0341_168_41_20170510_00083.jpg

Looking downstream from levee mile 3.94 at tall unwanted weeds and other vegetation on the waterside shoulder and slope.

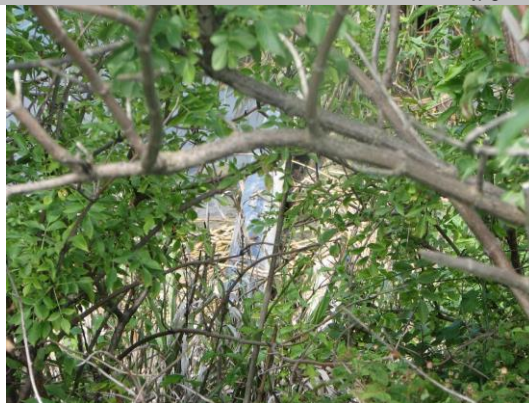
Photo 1 of 3 : UCIP_SP_2017_22203_37833.jpg

Limited access to waterward side--pipe visible through brush.

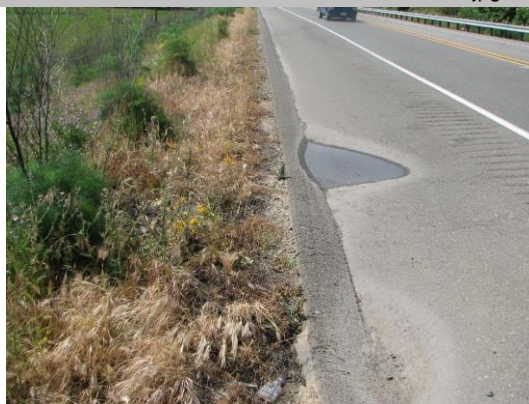
Photo 2 of 3 : UCIP_SP_2017_22203_37832.jpg

View of landward shoulder and low spots on highway.

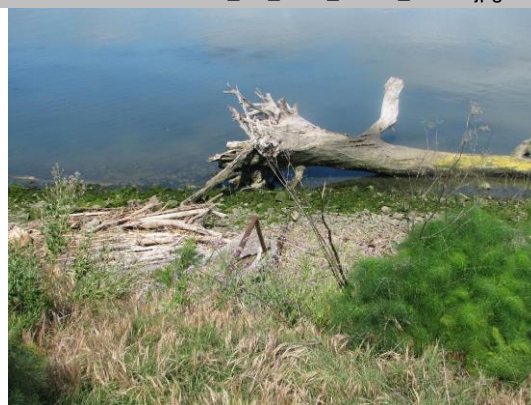
Photo 1 of 2 : UCIP_SP_2017_22186_37787.jpg

View of crossing on waterward side--dense vegetation on slopes.

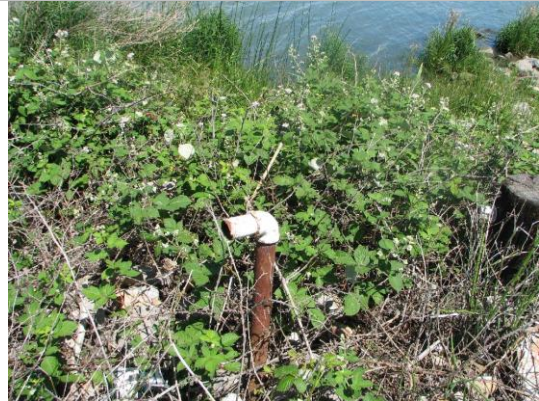
Photo 2 of 2 : UCIP_SP_2017_22262_37952.jpg

View of waterward side air vent pipe could be associated with crossing.

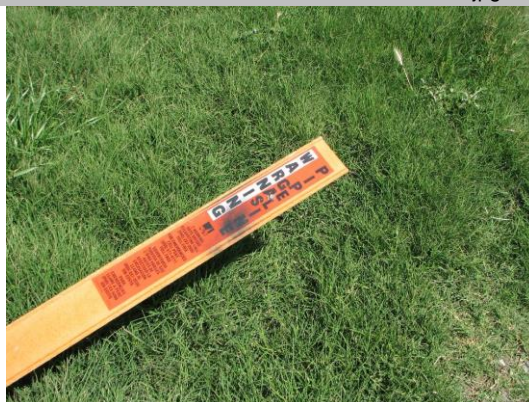
Photo 3 of 3 : UCIP_SP_2017_22263_37960.jpg

Marker damaged on waterward side.

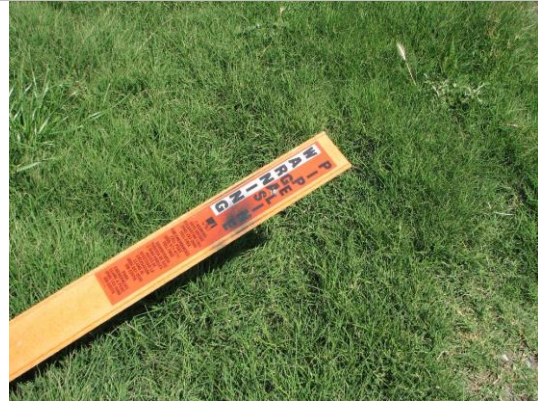
Photo 3 of 3 : UCIP_SP_2017_22264_37963.jpg

Damaged marker located on waterward side.

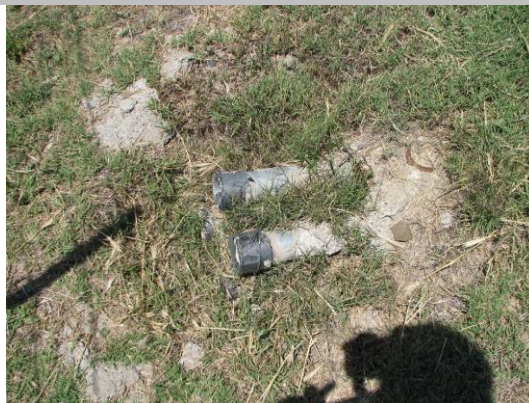
Photo 3 of 3 : UCIP_SP_2017_22303_38060.jpg

View of conduit on landward side. Four 2.5-inch conduits through levee not in use yet.

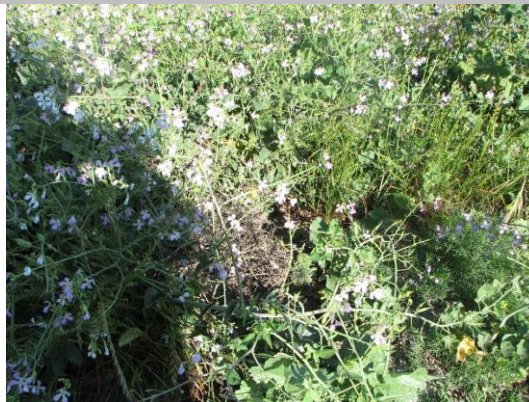
Photo 2 of 3 : UCIP_SP_2017_22324_38095.jpg

Potential subsidence in slope however difficult to determine due to dense vegetation.
